Geologic, Structural and Geochemical Relationships in Southern Bonelli Park Near the I-57 Landslide Site

By
Kelly L. Kinder
Geological Sciences Department
California State Polytechnic University
Pomona, California

2011 Senior Thesis
Submitted in partial fulfillment of
the requirements for the
Bachelor of Science Geology Degree

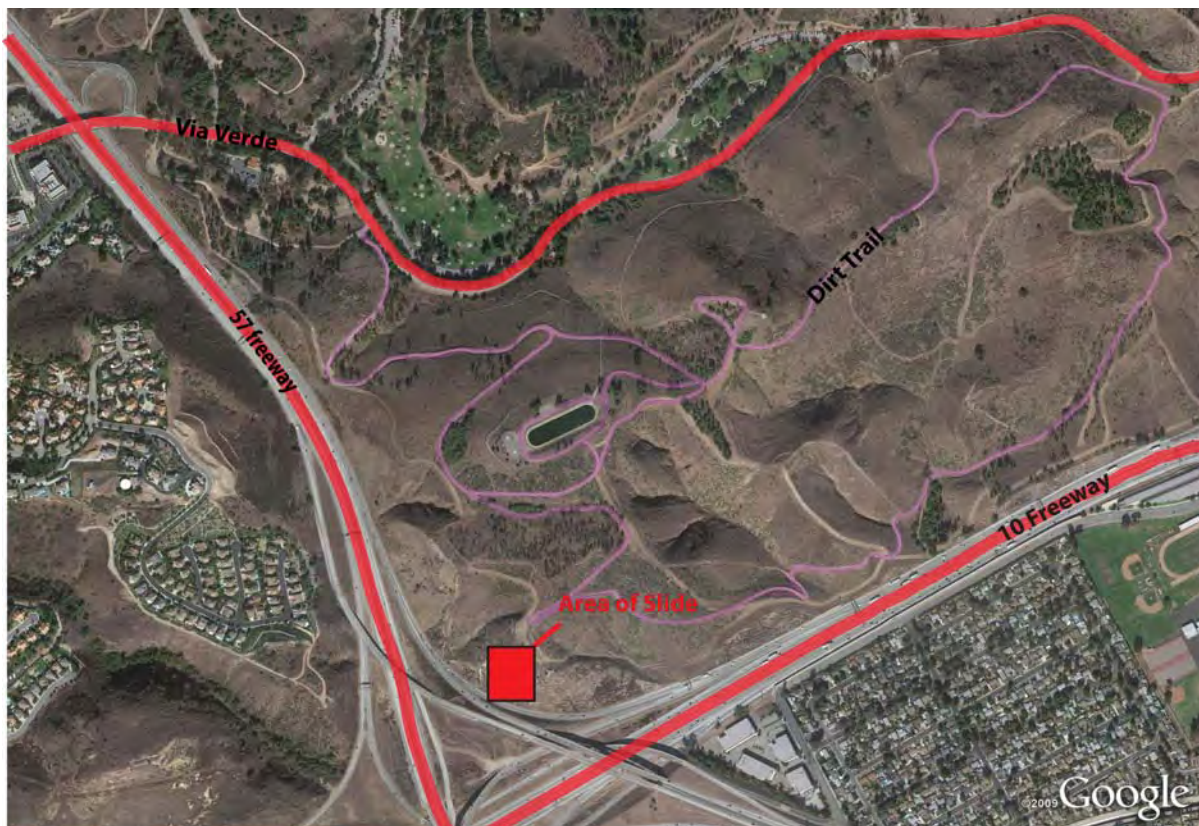
Figure 2. Pre-slide areal image with field site highlighted (Google Earth 2009).

The area of interest is located in the south western corner of Frank G. Bonelli Regional County Park in California. It is bound in the southwest by the westbound 10 and 57 north freeway interchange. Access to the base of the failed slope is by the eastbound 10 to the 57 northbound interchange. This was only allowed by special permit through Caltrans personnel on March 9, 2010. Access to the top of the slide and surround hillsides is accomplished by taking the Via Verde exit from the 57 freeway and entering Bonelli Park. The dirt trail is wide enough to allow vehicles but permission is required to gain entry thus I walked to the site.

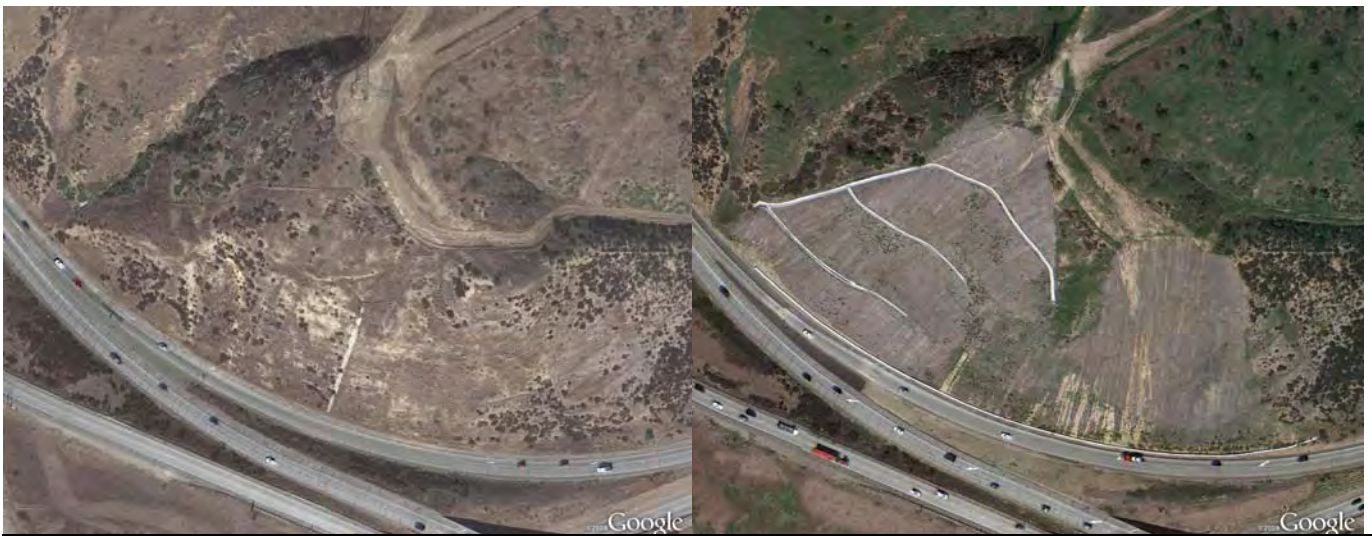
Figure 6: The image on the left shows what the area looked like on November 19 2009. The image on the right shows the area March 8 2011.

Follow up trips were taken between January 14th and April 26 2011. These trips involved mapping contacts, taking attitudes on bedding and fractures, note taking **Figure 5** and sample collecting. Heavy vegetation, such as cactus, along with steep valleys and erosion inhibited mapping in a great deal of areas. The aerial photos below **Figure 6**, obtained from Google Earth, show pre and post slide images.

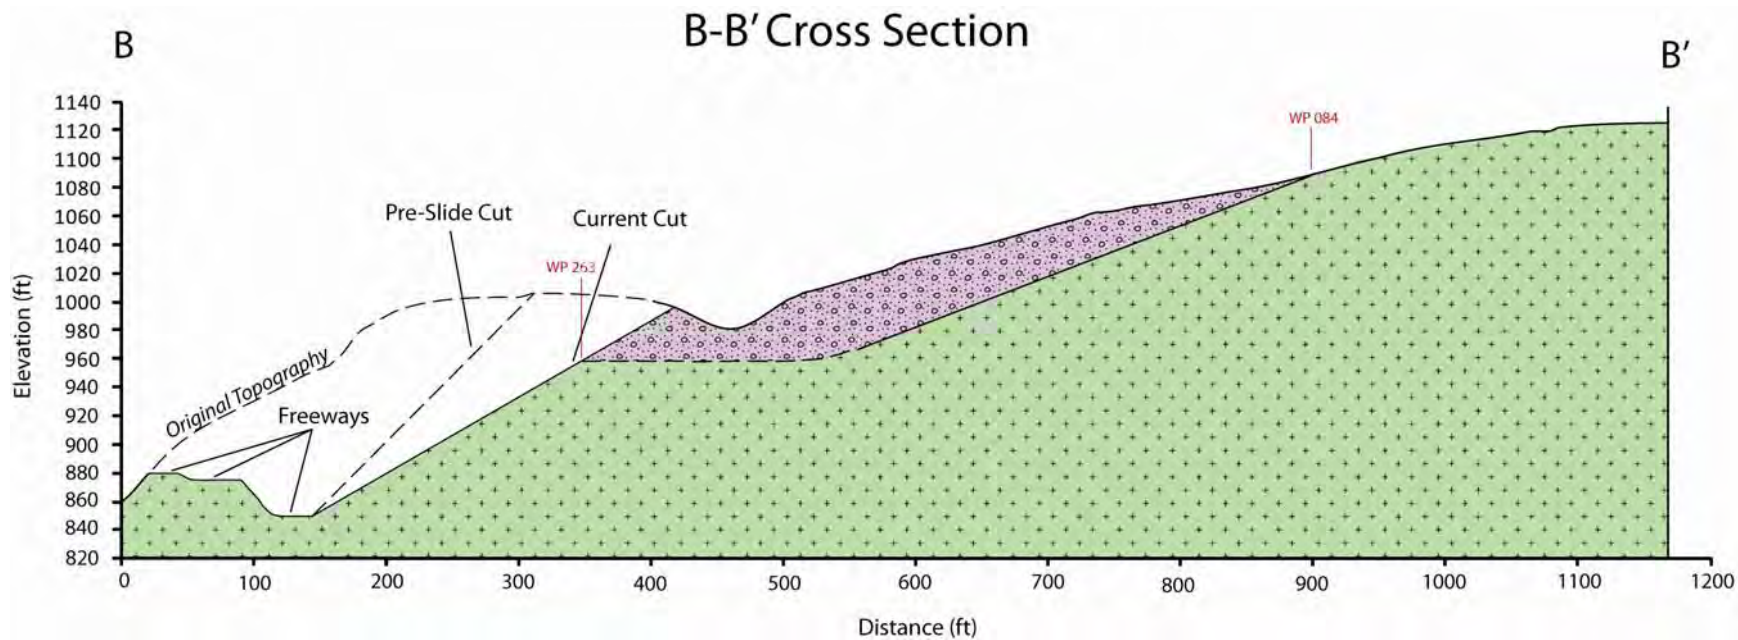
Figure 10A: B-B' cross section with original USGS 1966 topography. NOTE: This cross section is 200 feet less than the figure above.

Two cross sections were produced from the geologic map (**Figure 9, 10**). Cross section A-A' trends north-east and crosses the slide slope and power line tower. Cross section B-B' trends north-east as well and shows the geology just east of the slide. Both cross sections were created with the use of the USGS topographic map however; this map base was created in 1966 before the construction of the 57, 71, and 10 freeways and the topography was severely altered in the mid 1970s. Because no newer map bases are published, I used Google Earth functions to get fairly precise locations of the existing freeways. A 1-1 cut was assumed for pre slide conditions and a 1-2 cut for the present post-slide situation.

There was some difficulty in generating the cross sections. The first complication was that the 1966 USGS topographic map was made before the freeways were in place. This meant that the current topography is completely different and the waypoints taken on the slope adjacent to the freeways were not located in the proper elevation. **Figure 9 and 10** show how the waypoints plot on the 1966 topography. Once it was understood that the topography was incorrect the next challenge was creating a cross section that incorporated the various road cuts. Information of the exact slope was unavailable thus it was assumed that the original road cut was 1:1 whereas the current road cut is 1:2 as shown in **Figure 9A and 10A**. The only information that was available was the cut was made 50ft away from the electrical tower. The last obstacle was finding the correct elevation for the freeway transition roads. Google Earth was used to get an estimate on the elevations and widths of each transition road.

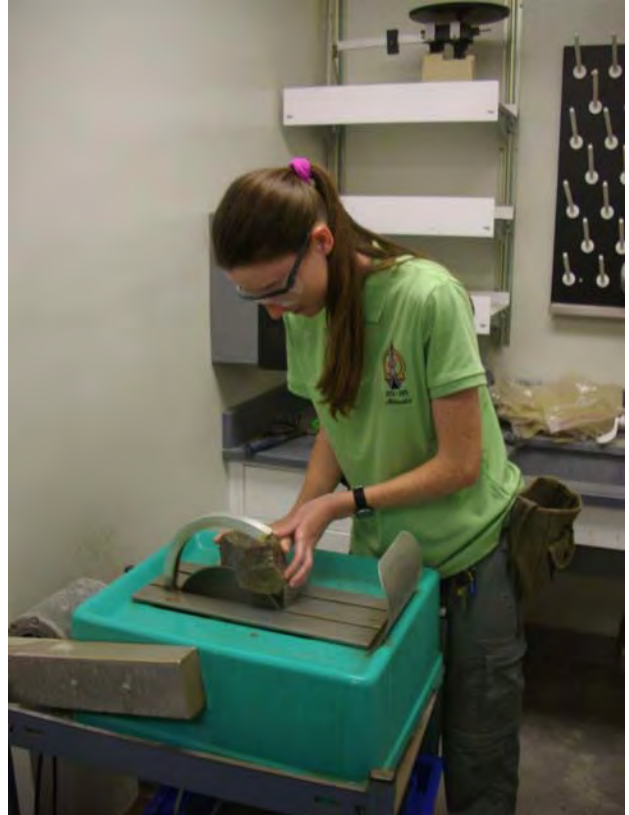
Figure 13: Preparing a sample for XRF analysis.

All samples were prepared by being cut with a hand saw in order to remove weathered material (**Figure 13**). They were left to dry in an oven set to approximately

300°F. The samples were then crushed using a Braun Chipmunk jaw crusher. The smaller pieces were grinded in a SPEX 8000 Mixer/Mill with steel balls until they were able to pass through a 45 sieve (0.355 mm) while the rest were stored for possible further analysis. The powdered sample was mixed with cellulose and held under high pressure in order to create the pellets that are used in the XRF. The results from the XRF were then plotted on a total alkali to silica diagram (TAS). This particular diagram is based upon Le Maitre et al 2002. Full results are tabulated in **Appendix B** where as the TAS diagram can be seen in **Figure 15**.
